[New posts](#) [Find threads](#) [Watched](#) [Search forums](#) [Mark forums read](#)[Home](#) [Forums](#) [L300 forums and info](#) **L300 Technical Q&A**

# Lower Ball Joint Questions

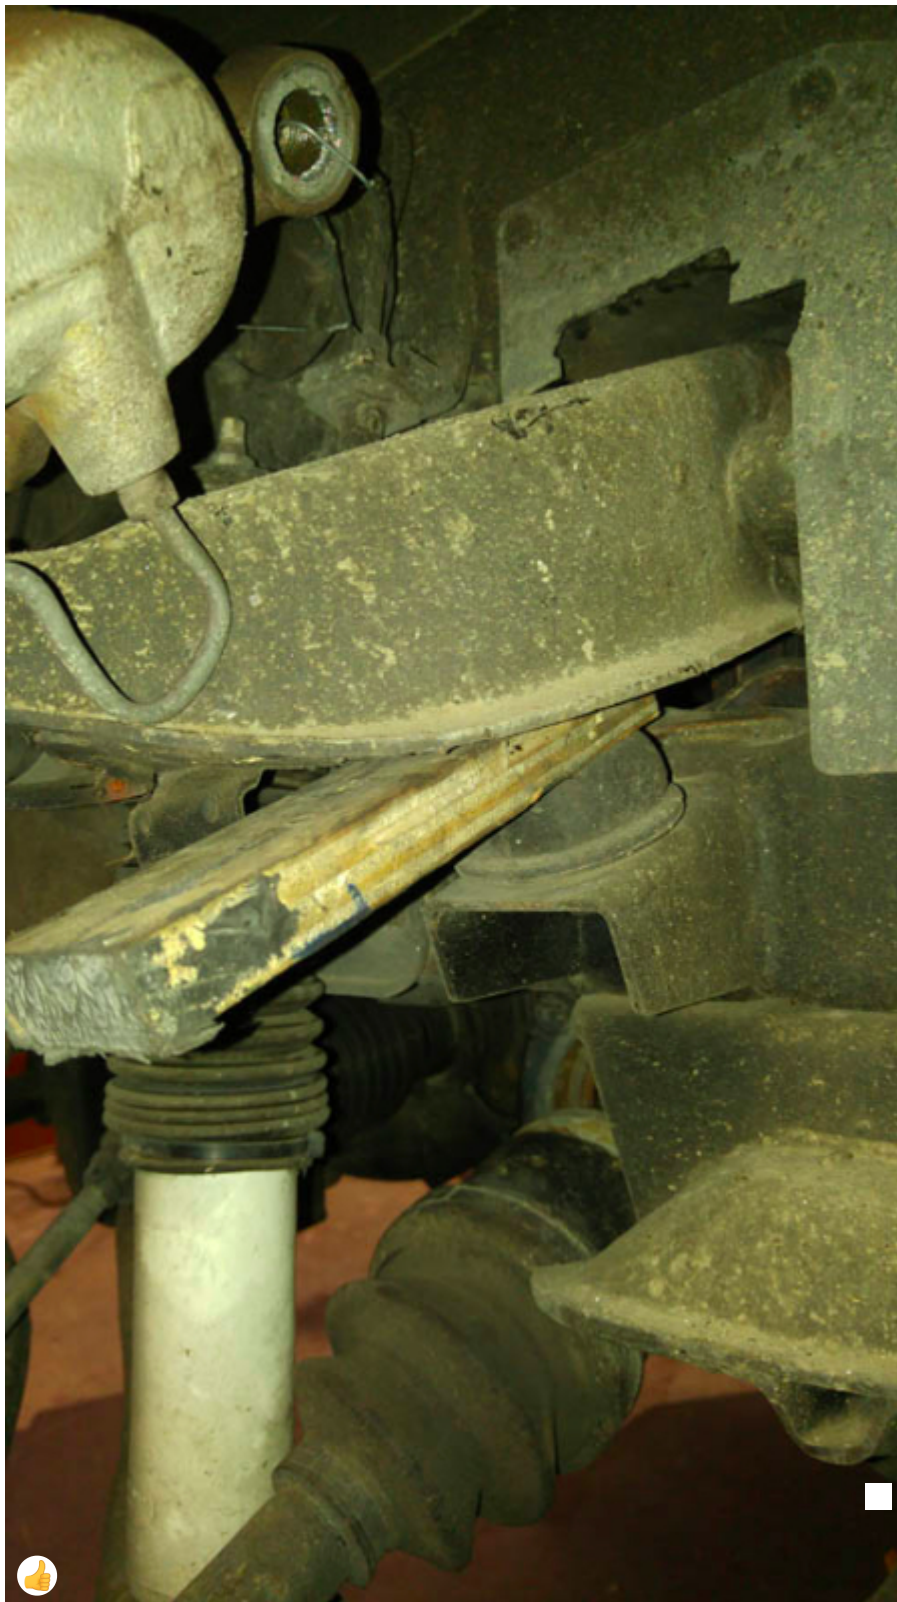
Before jacking the van up, put a spacer between the upper arm and rebound stop...

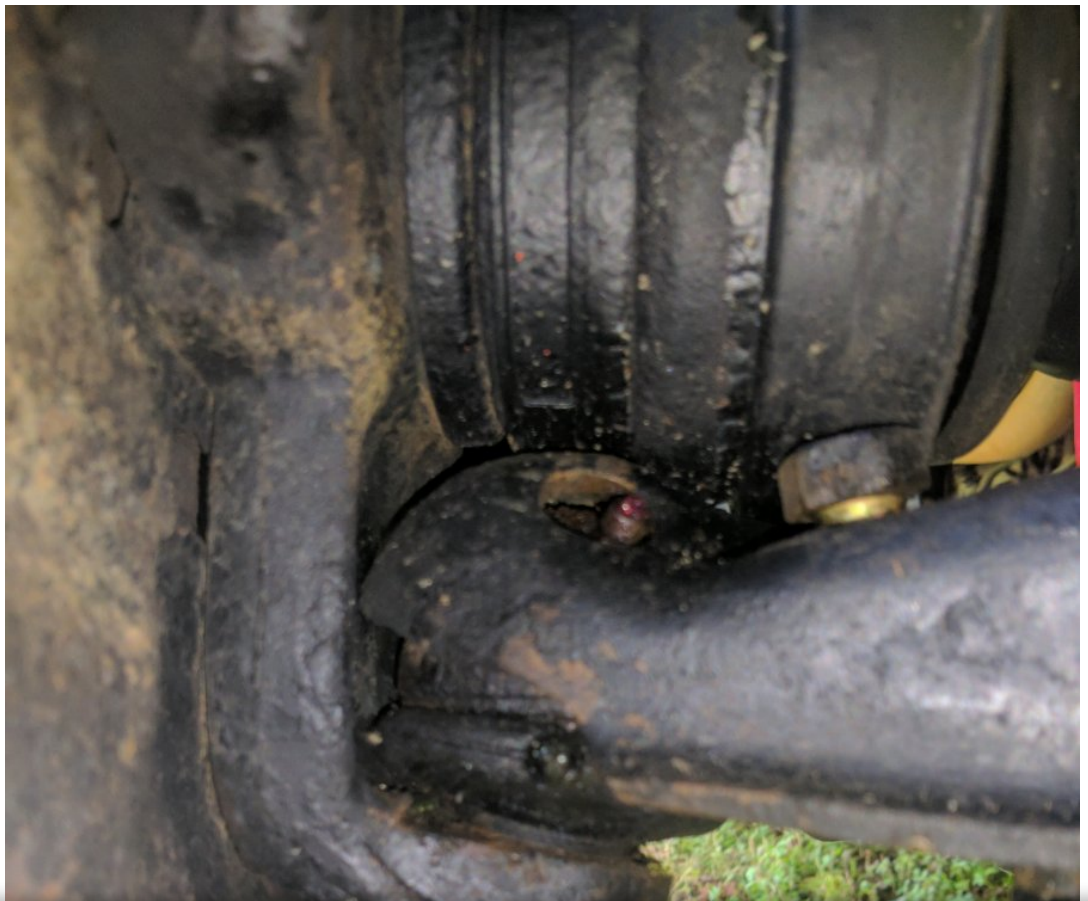
The lower knuckle wraps around and below the ball joint, so there doesn't seem to be a lot of space to actually separate them, and the out CV restricts the upward movement of two of the four ball joint bolts and the lower control arm. (Seems like a really obtuse design.)

I thought the whole hub swung out, pivoting on the top balljoint, bringing the lower balljoint with it, but it looks like you don't even have enough clearance to remove the 4 bolts.

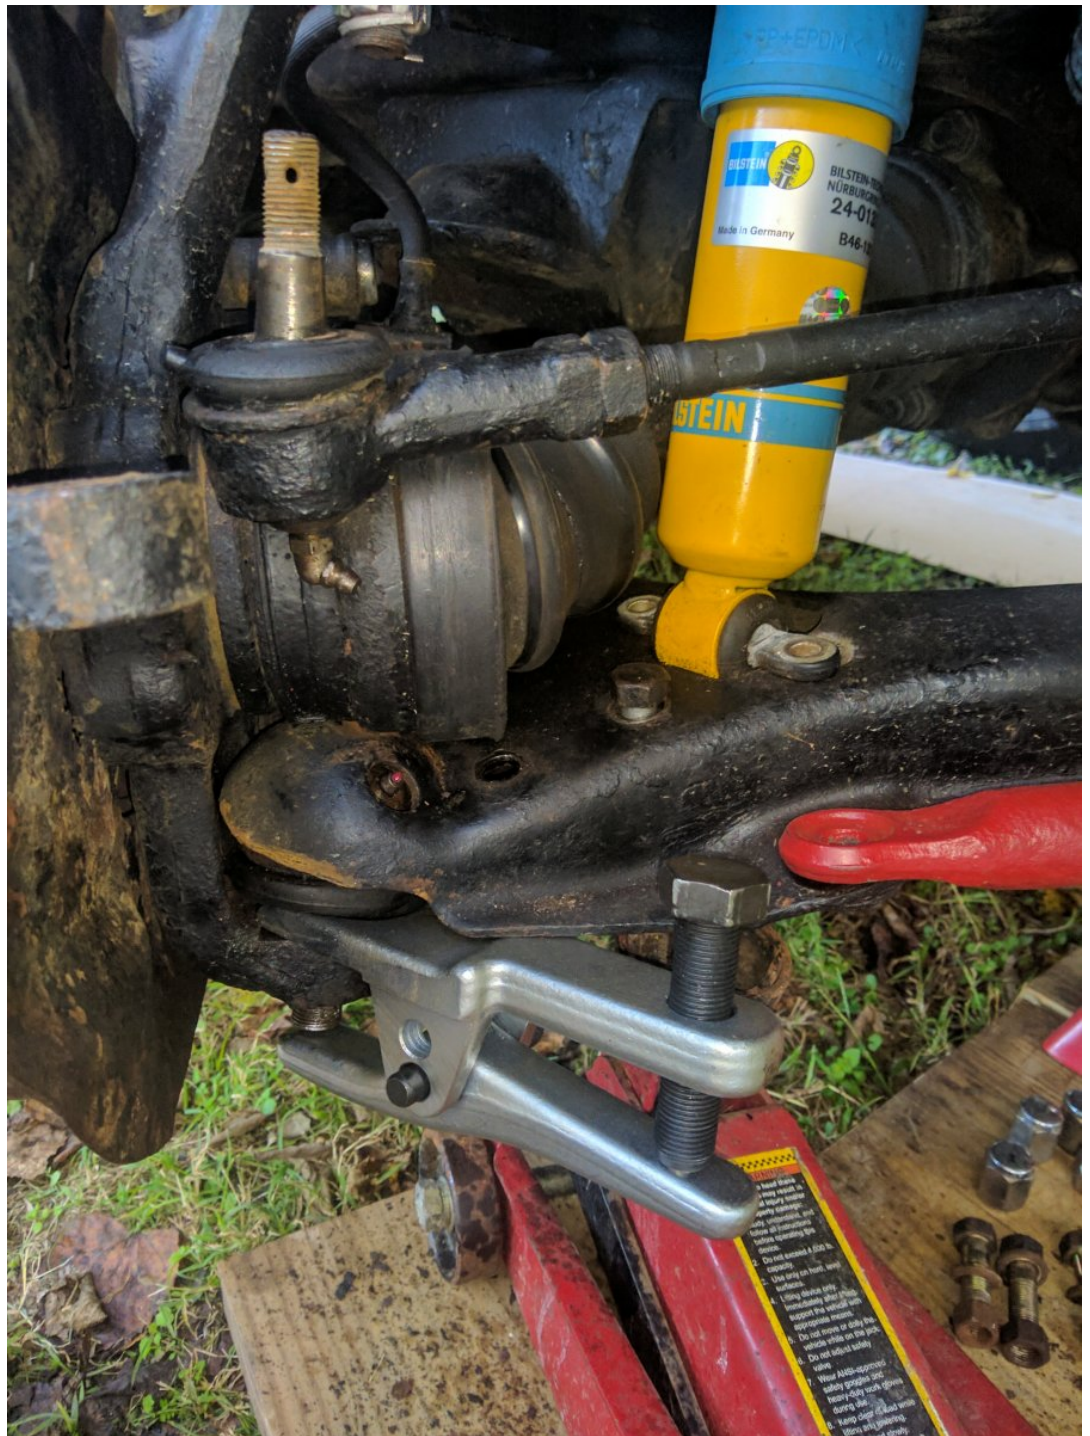
- Popped the lower ball joint (which took A LOT of persuassion and PB Blaster.). Put a little pressure under the lower control arm with a jack to lift the arm a bit.

Notice the angle of the separator. Any other angle wouldn't allow the tool to grab, and it would pop off as I tightened it.

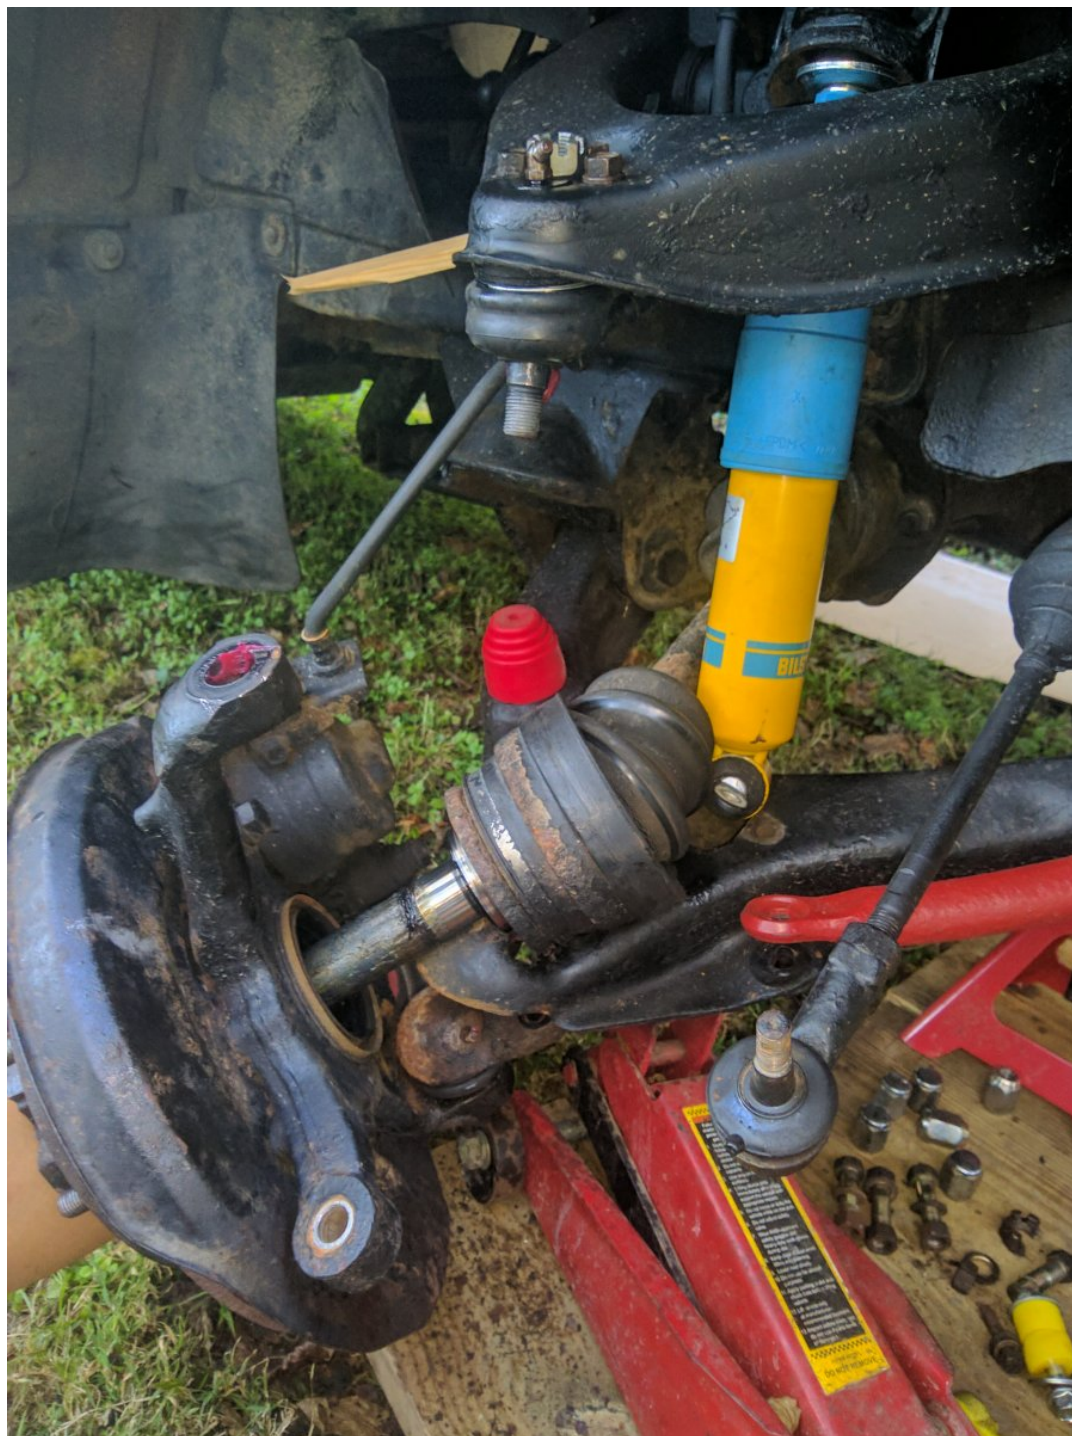
- Once the taper was loose, and all bolts out of the ball joint mounting legs, it was then a wrestling match to actually get the lower taper stud out of the lower knuckle, but it can be done. Notice how taut the brake hose is from the weight of everything. Don't let it stay like that.

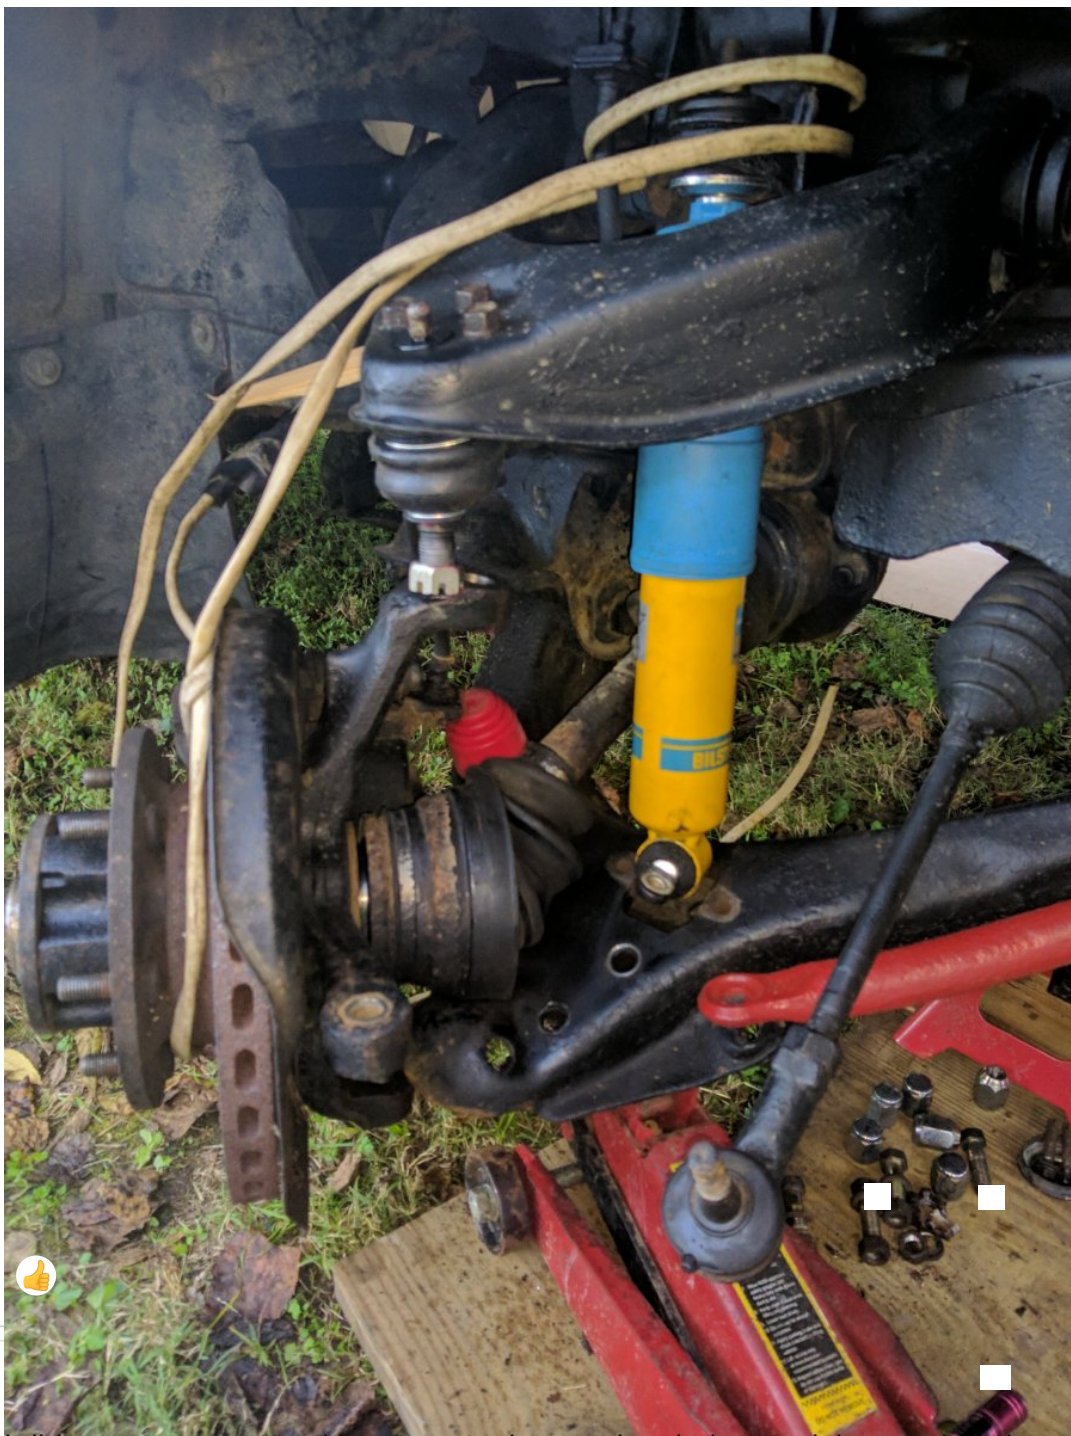
Anyway, hang the heavy hub/knuckle/brake assembly from the framework above the shock to get the weight off of the brake lines, like this:
